## **BERGEN TUNNELS REHABILITATION— A SUCCESS AFTER ALL**

### **ABSTRACT**

2001, the New Jersey Transit Authority commissioned the JV Merco-Obayashi with the rehabilitation contract of the approximately 130-year-old, 4,200 ft long, partially brick-lined Bergen North Tunnel. The contract entailed the tunnel enlargement, shotcrete and rock dowels initial support according to the NATM, a waterproofing system, tunnel drainage and a cast-in-place concrete lining. The rock conditions encountered required design adaptations and significant modifications of the initial tunnel support. Flexibility, skill and extensive experience on the Authority's and Contractor's side finally lead to a success. This paper describes the operations and design modifications carried out.

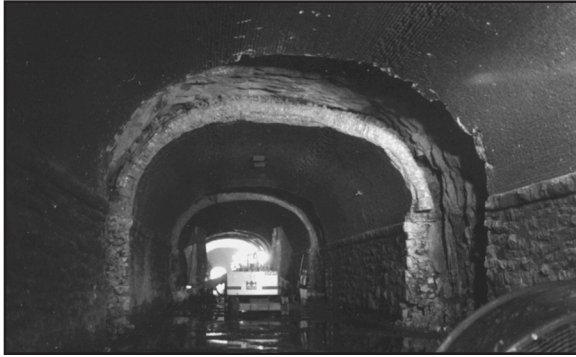
**Figure 1. Brick lined tunnel before rehabilitation**

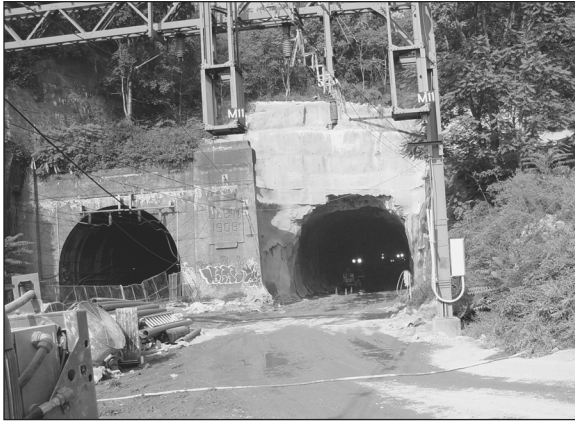
**Figure 2. Situation at the East Portal after backfill and tunnel lining removal**

At the East Portal, the excavation revealed a cut that is limited by blocky rock mass in the north wall and the rock portal face and fractured rock and rubble backfill towards the South Tube (see Figure 2). Loose rock mass conditions as consequence of the blasting impact of the excavation was visible.

Upon exposure of the existing tunnel roof and completion of the rock support installation above the tunnels, the demolition of the existing tunnel lining was carried out from the tunnel invert level in lifts and steps. In accordance with the lining removal steps, rock reinforcement was installed at the portal rock face and the sidewalls. The grouting of the central pillar between the North and South Tube proved particularly successful at the East Portal.

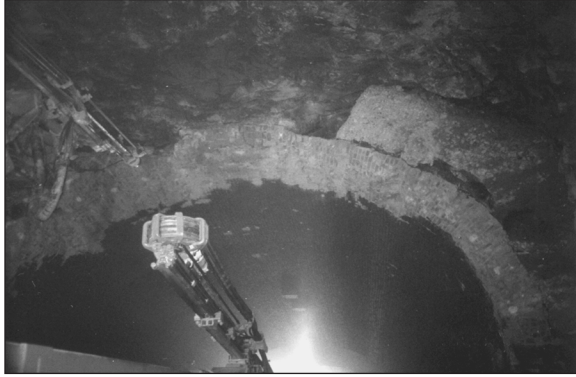
**Figure 3. Backfill material behind brick lining**

The removal of the brick and stone tunnel lining revealed blocky and fractured rock mass material that produced no to very small after-break. While the loose backpacking, grouted backpacking and concrete backfill behind the brick lining either fell out immediately after the excavation or had to be removed for safety reasons using hoe rams and excavators, the rock mass proved to be stable over the vast majority of the excavation length with sufficient stand-up time capacity over longer periods. Only localized areas of sheared and water discharging rock mass displayed some after-break of fractured rock chunks that had to be stabilized immediately. The area in immediate vicinity of the ventilation shafts and open cuts exhibited more fractured rock mass with limited stand-up-time capacity requiring early support installation. In some locations, rock slabs and blocks had to be scaled off or secured in place with rock dowels.

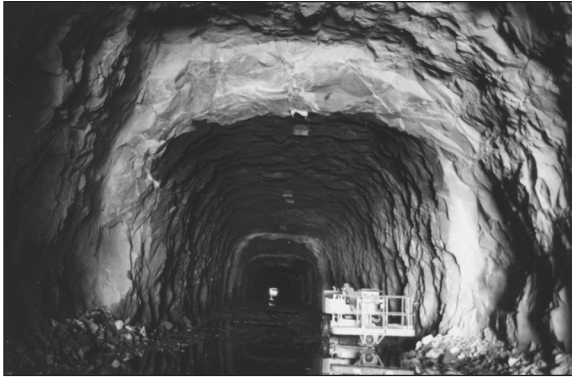
The blocky character of the rock mass with wide joint spacing in combination with joint set orientation and intersection produced significant over-break during the blast excavation when the tunnel was built as well as throughout the excavation for rehabilitation. The typical excavation profile resulting from blast excavation presented a rather flat, almost horizontal roof with steep sidewalls resulting in a trapezoidal tunnel profile (see Figure 4) which followed the dominating joint orientation. The resulting over-break had to be backfilled to meet the planned final tunnel shape. Using the lattice girders as template to achieve the theoretical tunnel profile, shotcrete thicknesses of up to 4 ft (1.2 m) had to be installed over significant tunnel lengths (see Figure 5).

Figure 4. Typical tunnel profile after excavation

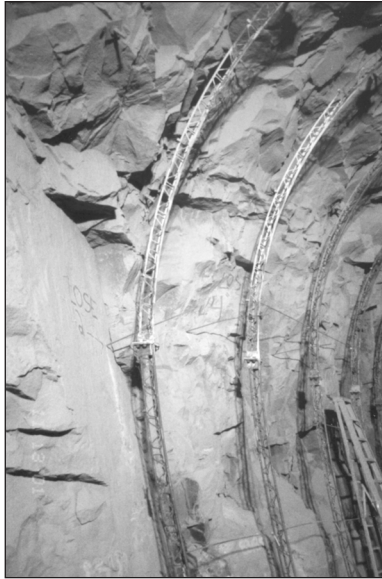
Figure 5. Over break in tunnel shoulder area

The over-break resulting from the tunnel construction and enlargement was filled with concrete during the installation of the cast-in-place concrete final lining.

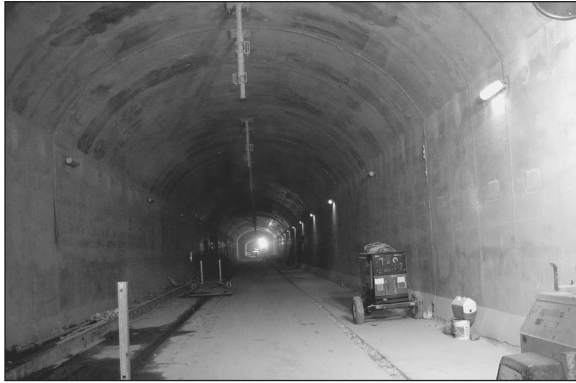
Figure 6. Final concrete lined tunnel
