Metro Transit - St. Louis Leak Remediation Design Bi-State Development Agency

Inspection and Design Services for Tunnel Leak Remediation:

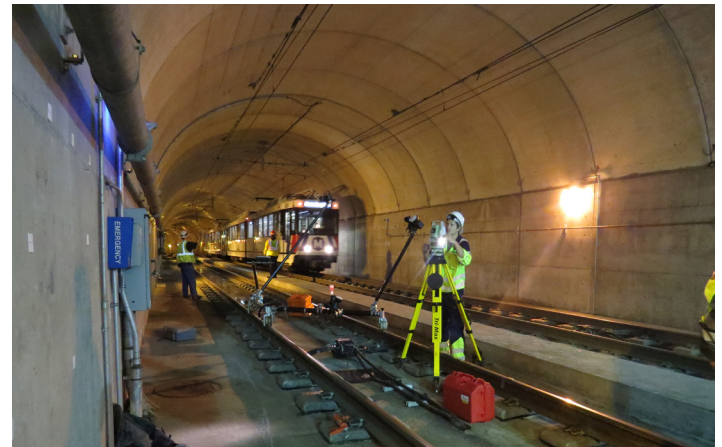
Figure 1. Digital Scan of Tunnel #3 During Detailed Inspection

This water leakage has contributed to early concrete deterioration, as well as other serviceability issues. Gall Zeidler Consultants (GZ) initially performed a leakage assessment, analyzing possible causes of tunnel leakage into these structures. The Bi-State Development Agency (METRO) then tasked GZ with performing detailed leakage inspections of the structures affected by the leaks. These inspections determined both the location and severity of any water infiltration in the both tunnels and stations. Included in these inspections were digital tunnel scans.

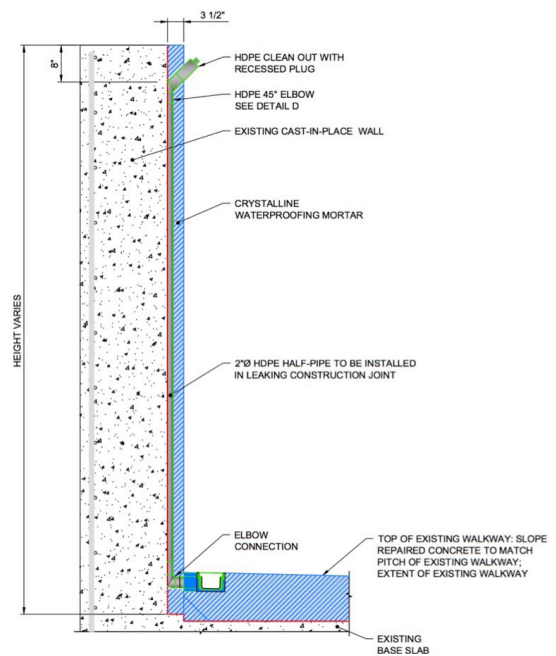
Figure 2. Cross Section of Vertical CIP Wall Construction Joint Repair

Following the completion of the inspections, GZ has been tasked with performing a leakage remediation design. This design includes installing drainage pipes into the walls of the tunnels, and conveying water gathered in these pipes to existing tunnel drainage. Areas displaying leakage which are not treated with the drainage pipes will be addressed using crystalline waterproofing material and hydrophilic injection grout. The methodology of this design will halt the water intrusion without significantly changing the leakage regime.
