## Solu River Hydropower Project Solu Hydro Power Private Limited

**Location:** Tingla Village, Solukumbu District, Nepal

**Date:** April, 2022

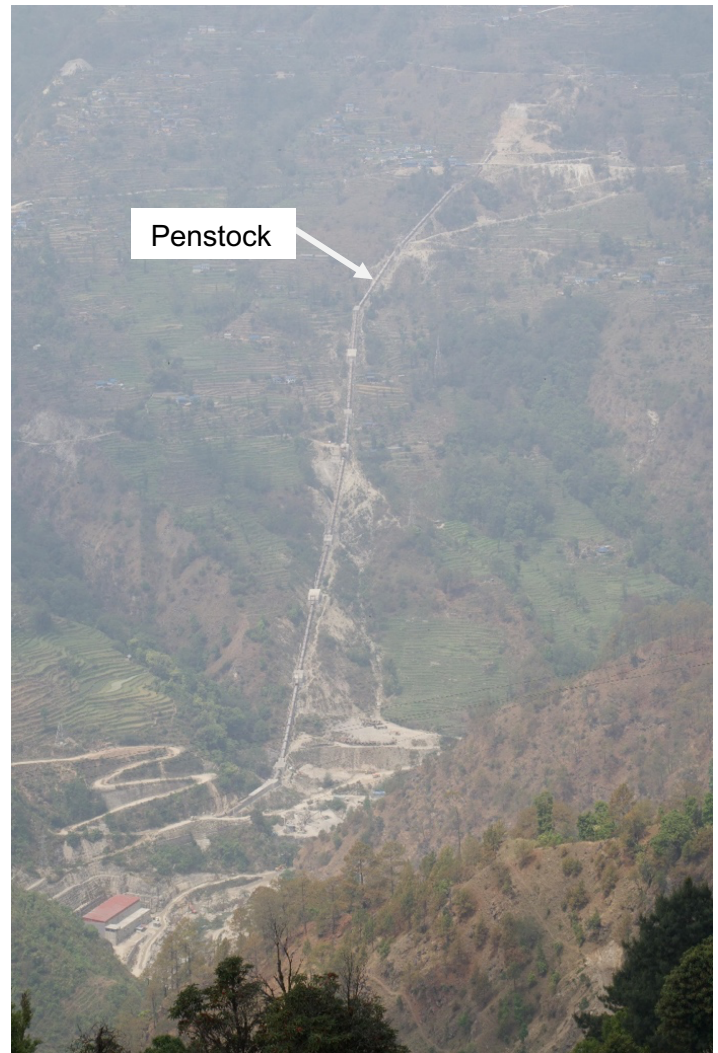
**Figure 1.** Penstock Alignment.

About 80% of the civil works of the project have been completed. There was an issue with the Penstock alignment at its site. Significant movement along and across the Penstock alignment was observed with development of tension cracks on the upper part of the Penstock together with displacement of Penstock joint.
