## WMATA Steel Tunnel Liner Structural Investigation Washington Metropolitan Area Transit Authority (WMATA)

## **GEC On-Site Inspection Support Services:**

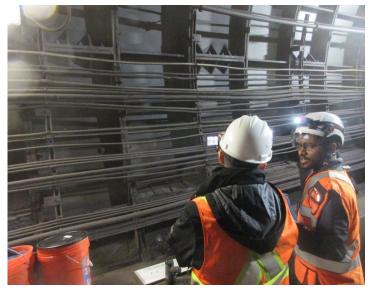
Figure 1. GZ inspector evaluating condition of steel tunnel liner.

A section of the WMATA tunnels on the Yellow Line in Washington DC near L'Enfant Plaza Station was constructed utilizing steel lining segments. During our Leak Remediation Inspection work, it was noted that severe corrosion and section loss were present on many of the segments, particularly below spring line. The project team recommended, and WMATA agreed to conducting detailed inspections and measurements of the steel thickness, and developing a recommendation for an engineered solution. Each steel segment ring element was inspected panel by panel, and material thickness was tested at randomized locations where severe corrosion was noted. A report summarizing these findings, the structure history, rehabilitation alternatives, and recommended approach was prepared and submitted to WMATA.

Gall Zeidler Consultants (GZ), as part of the GEC team, coordinated inspection tasks with WMATA personnel and provided inspection staff for the evaluation and documentation of the conditions of the steel panels and associated features (e.g. bolts, ribs, etc.). GZ also participated in developing the report summarizing the inspection findings, suggesting remediation methods, and providing remediation recommendations.
