Preprint 15-131

INNOVATIVE REHABILITATION OF EXISTING TUNNELS UNDER MINIMUM IMPACT ON OPERATION

A. G. Nitschke, Gall Zeidler Consultants LLC, Ashburn, VA
J. Dase, Rio Tinto - Kennecott Utah Copper, South Jordan, UT
I. Ossenbühl, BuM Beton-und Monierbau GmbH, Herten, Germany
W. Dolsak, DSI Underground Systems Inc., West Jordan, UT

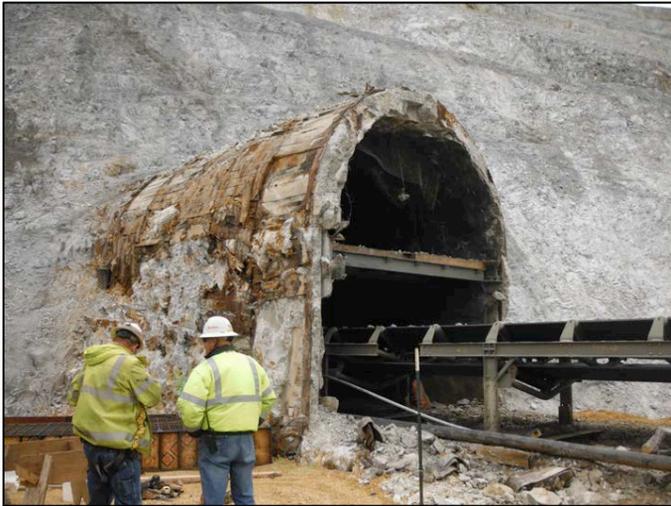
Figure 2. C6 Tunnel, partially unearthed during open pit mining activity

Figure 1 shows the typical geometry and support system of the C6 tunnel as completed in 1959. Figure 2 shows the C6 Tunnel in an area where it is partially unearthed by surface mining activity. Steel sets embedded in the concrete lining can be clearly seen, as well as timber lagging at the extrados of the lining. The deck shown in Figure 2 is not typical for the tunnel and just used close towards the pit portal and has no structural support function.

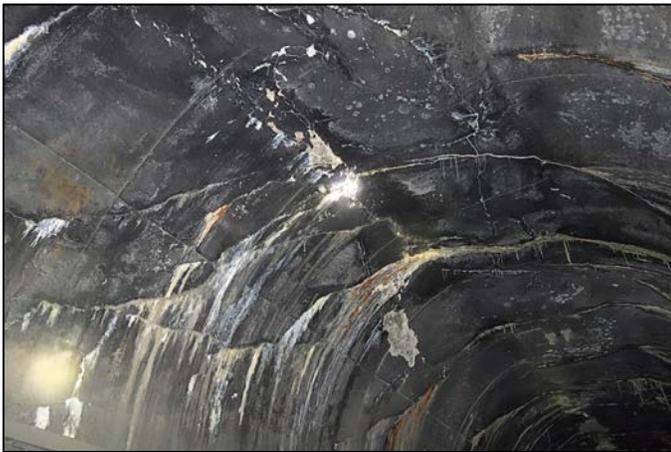
Between January and June of 2014, excessive and progressing damage was observed from the pit portal at table #56 to table #121 (Figure 3). Spalling of concrete slabs from this section of the liner led to partial closure of the tunnel to access in early June. Significant damage was reported within the approximately 200-foot tunnel section along the Fortuna fault. The remaining portion of the tunnel between the Fortuna fault and the pit portal was also reported to have increasing rates of deterioration. As a safety precaution, access to the tunnel had to be restricted between the pit portal towards the end of the Fortuna fault crossing.

Figure 3. Typical damages in the tunnel's back.

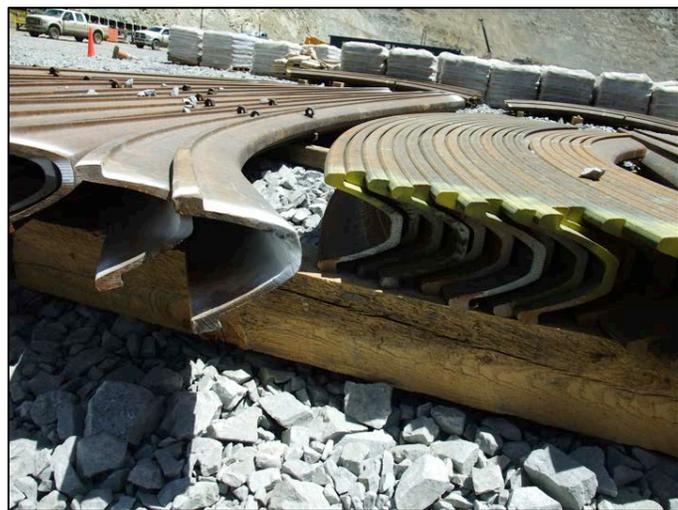
Figure 4. TH steel sets in a storage area and principal assembly of the TH system.

The yielding support system used for rehabilitation of the C6 tunnel consisted of TH steel sets with yielding locks (Figure 4). TH steel sets were originally developed by H. Toussaint and E. Heintzmann in the 1930's for mining operations in Germany, which are prone to highly squeezing ground conditions under high pressure. Due to its special shape, single interleaved TH sections are easily connected by different types of lock systems, which are defined by German standards [1], [2] (Figure 5). This allows both an easy and fast connection of single segments in underground operations. Different types of TH sections are available and classified according to their nominal weight in [kg/m], which equals 0.672 [lb/ft]). For the present application, TH-25 and TH-29 type segments have been used. The nominal weight of these profiles is 25kg/m (17 lb/ft) and 29kg/m (19.5 lb/ft), respectively.

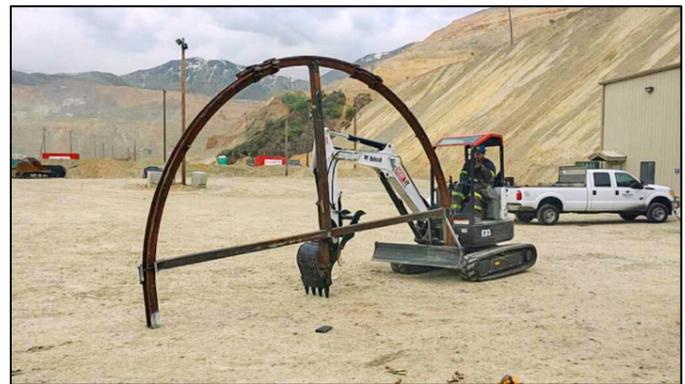
Figure 10. Mini-excavator and jig, at fabrication shop.

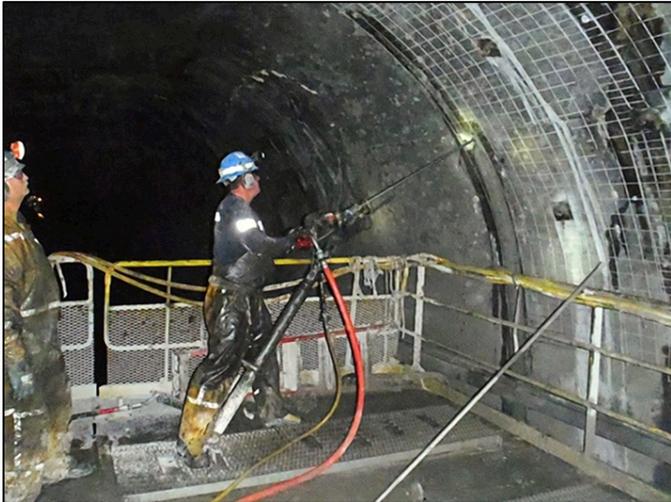
Figure 11. Bolting work deck.

A team of structural engineers re-designed the bolting deck. Reinforcements and additional guarding were fabricated and installed before the deck was commissioned. The services for this deck were supplied from the mine side of the tunnel. Air and water was supplied by hoses, pulled through the damaged sections of the tunnel using a 1 yd³ LHD fitted with a tele-remote package. Split Set Bolts and OMEGA-BOLTS were used with bolt selection dictated by the required longevity of each system. The installation was complicated, because the embedded steel sets of the original lining were fully encapsulated in the existing concrete tunnel liner. The lagging material and cribbing located behind the liner provided additional challenges. The bolting deck was commissioned on July 22nd and was decommissioned on August 19th after securing approximately 926 feet of tunnel.

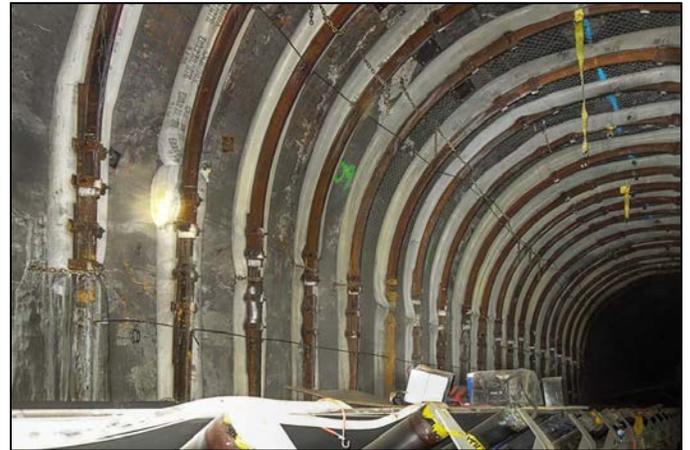
Figure 13. Completed tunnel section with TH steel sets.

set spacing is fixed to 3 foot centers for all repair work using the work deck. The monorail system has allowed set installation over the running belt with work continuing at a rate of 6 sets per day or 18 feet per day.
