# Estimating lateral support pressure for rock cuts at Washington-Dulles International Airport expansion

**ABSTRACT:** Washington-Dulles International Airport (Virginia, USA) has been expanding its capacity since 1999. This expansion has required extensive vertical, open-cut rock excavations to depths of up to approximately 20 m adjacent to existing infrastructure for construction of new below-ground stations for the new Automated People Mover (APM) passenger transportation system. As the construction could not impact the airport operations, the selection of support pressures for the rock excavations had to balance the projects' risks and construction costs. Site investigation identified that bedding dipping at approximately 30° would be the primary hazard to the vertical rock cuts. Extensive laboratory testing and field observations suggested that the potential for a large slide along a bedding plane was relatively low. Therefore, design lateral pressures for permanent station walls were based on a potential failure model of local wedge/block failure. The reduction in lateral support requirements for the permanent below-grade walls for the APM station structures resulted in signi

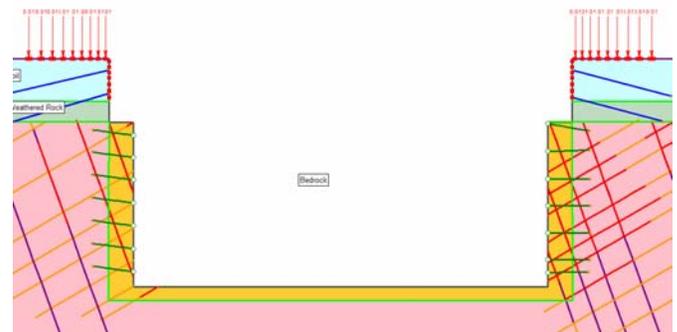
Figure 8: Phase2 model at the end of excavation with the anchors installed.

A total of 17 stages were used in the analyses. Stage 1 was used for initial equilibrium and Stages 2 to 8 were used for excavation and installation of the support (Figure 8). Stage 9 was the application of a surcharge of 12 kN/m to the top of the slope and Stage 10 was the application of the blast-induced damage. This was uniformly applied to

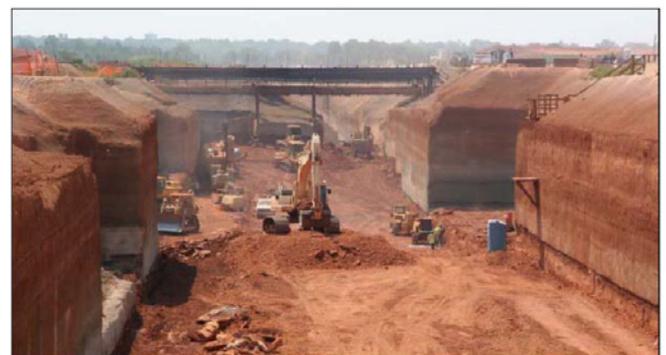
Figure 11: Typical rock cuts at Dulles Airport site (Tier 3 Excavation, photo from McQuinn et al 2006)

Today there have been several thousand lineal metres of rock cuts at the Dulles Airport site, varying in height from 5 to 25 m. All of the cuts in rock have been vertical and excavated using either blasting, saw-cutting, or roadheader techniques (Figure 11). In excavations adjacent to buildings and equipment blasting is very carefully controlled.

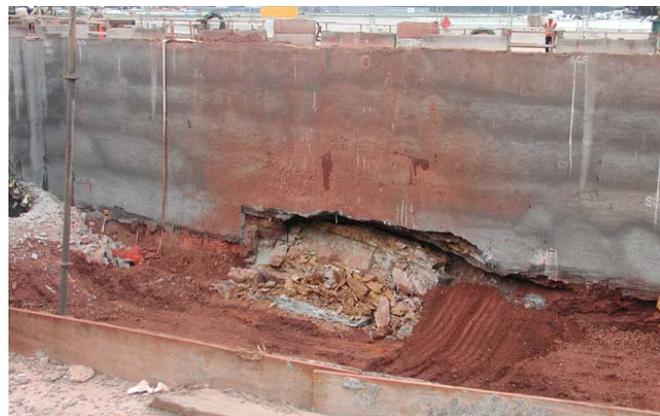
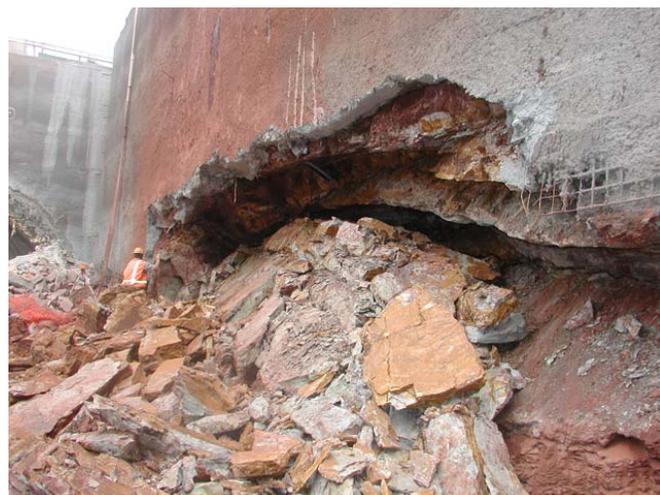
Figure 12: Localised failure along a bedding plane when a double-height bench was excavated.

In one excavation, a double bench height was taken and this extra bench height resulted in localized failure along a bedding plane (Figure 12). Inspection of the failure suggested that the instability was bounded by the bedding planes and the sub-vertical joint planes, similar to the mechanism shown in Figure 5. Periodically, smaller (<4m<sup>3</sup>) wedge falls have formed, but these have typically

formed near horizontal and vertical corner excavations where confining stresses have been reduced.
