# **Risk Reduction, Management, and Mitigation from Experience-Based Learning During Construction of Cross Passages, Seattle, Washington**

## **ABSTRACT**

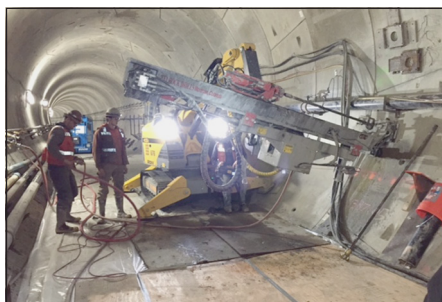
Figure 4. Ground probing from inside of the TBM tunnel

**Probe Drilling.** Probe holes were drilled prior to installation of pre-support to verify geology before excavation of the cross passages (Figure 4). The probe holes were arranged in a systematic manner to cover the entire excavation face area and a zone around the excavation perimeter, and inclined to ensure that as many granular layers/lenses as possible could be intercepted in one boring.

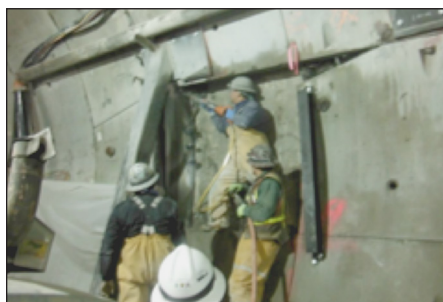
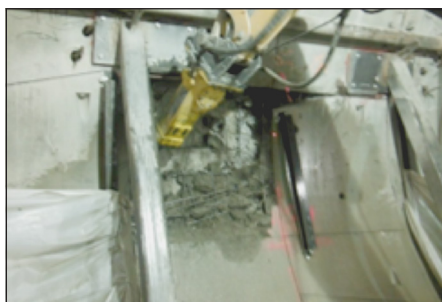
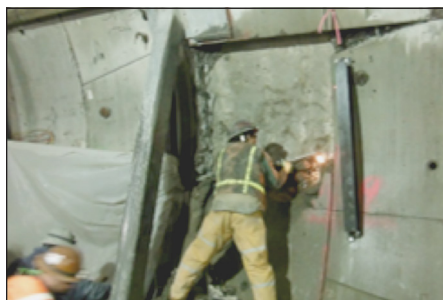
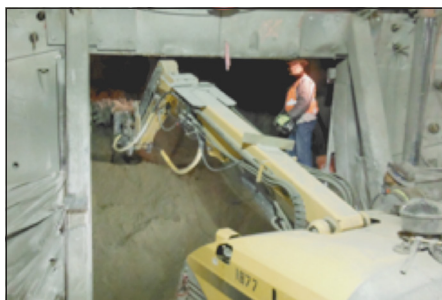
Removing rebar and bicone dowels

Breaking upper left segment

Exposed grout behind segment

Excavating after removal of segments

Figure 5. Break-in to the cross passage

**Cross Passage Breakout Support.** Shear Bicone Dowels were installed between the running tunnel lining segments at cross passage breakout locations and the segments were propped using vertical steel propping. The Shear Bicones were used to transfer loads from cross passage opening to the running tunnel lining. The TBM lining segments were saw-cut to form the required opening (10'x10') for the break-out (Figure 5). Segments were broken with a hydraulic hammer and removed. The edges of the segmental lining were protected with temporary wooden protection blocks to avoid damaging the segments. Upon removal of the segments (or parts thereof), steel fiber reinforced shotcrete was immediately applied over the exposed ground surface to stabilize the face.

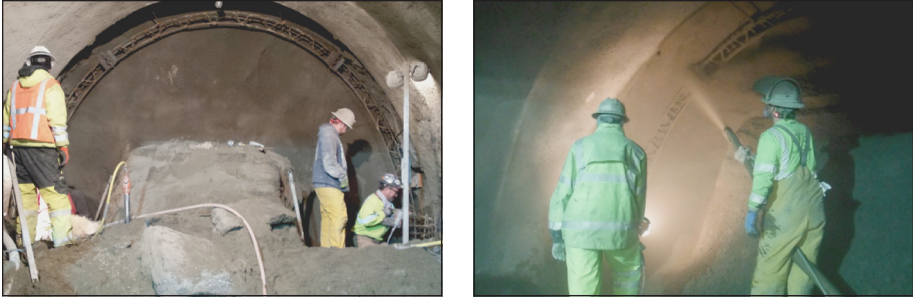
**Figure 6. Lattice girder and shotcrete installation at the top heading**

rounds of excavation and support. The full ground support comprising of lattice girders and steel fiber reinforced shotcrete was installed immediately after completion of each excavation round. A two inch thick flashcrete layer was installed at the face and covered all other exposed ground surface immediately after completion of each excavation round. Following the flashcrete application, a pre-fabricated lattice girder was installed, followed by application of an additional six inch fiber reinforced shotcrete layer (Figure 6). The flashcrete was an integral part of the eight inch thick shotcrete initial lining. All cross passages were over-excavated by three inches to account for construction tolerances and anticipated deformations. The general excavation and support sequence is:
