# Innovative Rehabilitation Approach for Overstressed Existing Linings Using an Adaptable Yielding Support System

## **ABSTRACT**

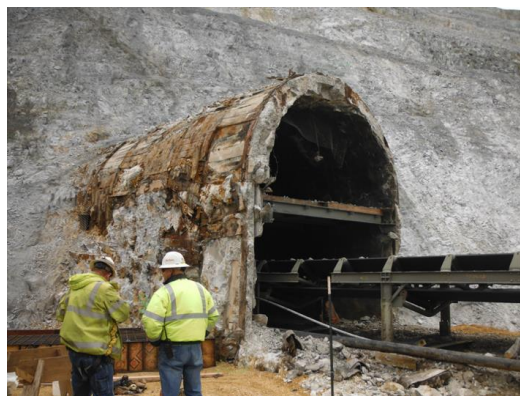
Figure 4 shows the typical geometry and support system of the C6 tunnel as completed in 1959. Figure 5 shows the C6 Tunnel in an area where it is partially unearthed by surface mining activity. Steel sets embedded in the concrete lining can be clearly seen, as well as timber lagging at the extrados of the lining. The deck shown in Figure 5 is not typical for the tunnel and was used close to the pit portal to protect the conveyor belt during demolition of the concrete liner, it has no structural support function.

**Figure 5: C6 Tunnel, partially unearthed during open pit mining activity**

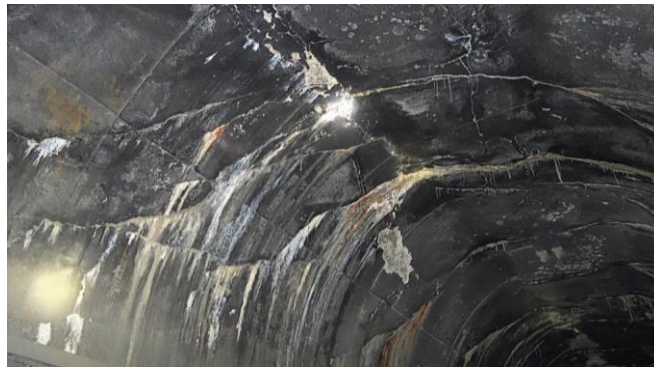
Between January and June of 2014, excessive and progressing damage was observed (Figure 6). The existing structure showed signs of overstressing due to movements in the surrounding rock mass. Wide, open cracks covering the entire circumference of the tunnel and spalled concrete and shotcrete were detected. Significant damage was reported within the approximately 200-foot tunnel section along the Fortuna fault. The remaining portion of the tunnel between the Fortuna fault and the pit portal was also reported to have increasing rates of deterioration. As a safety precaution, access to the tunnel had to be restricted between the pit portal and the end of the Fortuna fault crossing.

**Figure 6: Typical damages in the tunnel's back**

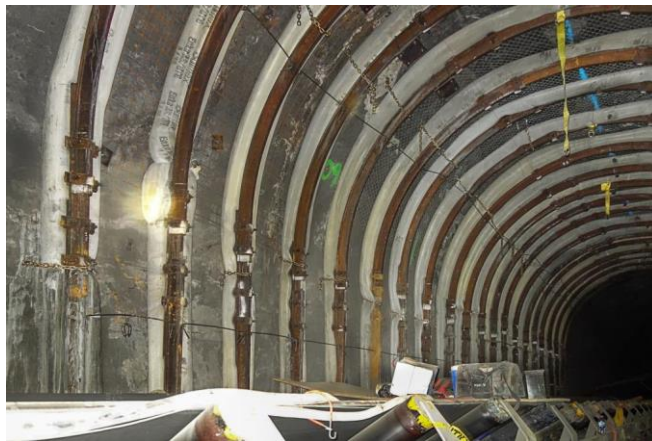
Figure 8 shows the finished rehabilitation with the installed TH steel sets and grout filled hoses with the conveyor belt underneath.

**Figure 8: Completed tunnel section with TH steel sets**
