NATM THROUGH CLEAN SANDS— THE MICHIGAN STREET EXPERIENCE

INTRODUCTION

A 100 ft long, 20 ft high and 18 ft wide NATM tunnel was excavated through grouted clean sands beneath a busy city street, including a variety of existing utility lines. The new tunnel associated with a hospital expansion will serve as a pedestrian tunnel connecting a parking structure with a new hospital facility.

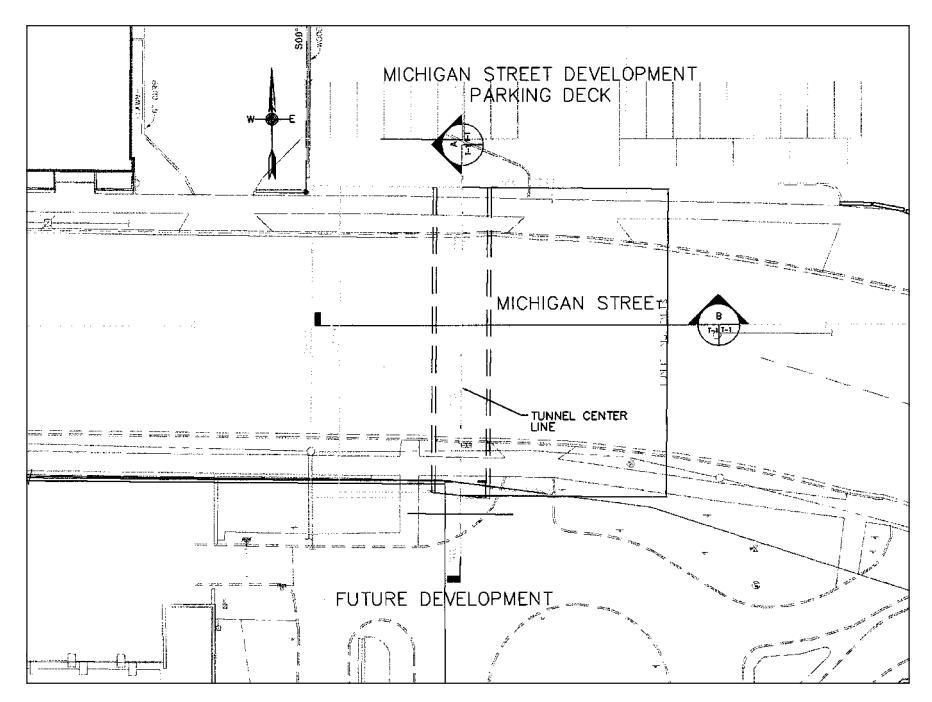
Figure 1. Site plan

The Michigan Street Pedestrian Tunnel is a component of the Michigan Street Development located along the north side of Michigan Street NE between Coit Avenue NE and North Division Avenue in the downtown area of the Grand Rapids, Michigan. The Michigan Street Development includes a parking deck and four new towers to be constructed over the proposed parking deck. The tower planned furthest east is being developed by Spectrum Health as the Lemmen-Holton Cancer Pavillion. The purpose of the pedestrian tunnel is to connect the proposed Lemmen-Holton Cancer Pavillion with the future Spectrum building to be located on the south side of Michigan Street NE. The southern end of the tunnel was constructed with a bulkhead until the future Spectrum building is constructed at which time interconnection will be required. The tunnel site plan and profile are shown in Figure 1, Site Plan, and Figure 2, Tunnel Profile.

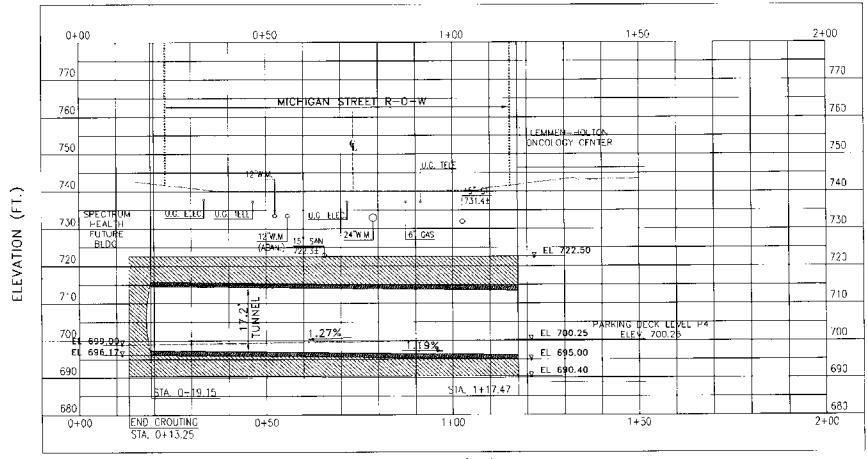
Figure 2. Tunnel profile

Existing Utilities. Several existing utility lines including several electrical and telephone conduits, a 6-inch gas main, a 24-inch water main, a 12-inch water main, an abandoned 12-inch water main, a 15-inch storm drain pipe, and a 15-inch sanitary sewer pipe are located perpendicular to the tunnel alignment along Michigan Street NE. Of particular concern was the presence of the high-pressure, 24-inch water main and the 15-inch sanitary sewer pipe. Refer to Figure 2, Tunnel Profile, for utility locations.

The 24-inch water main was believed to be a high-pressure cast iron pipe over 100 years old and located approximately 17 feet above the tunnel crown. The 15-inch sanitary sewer pipe was believed to be made of clay and located 7 feet above the proposed tunnel crown. The age of the existing 15-inch sanitary sewer pipe was not known.

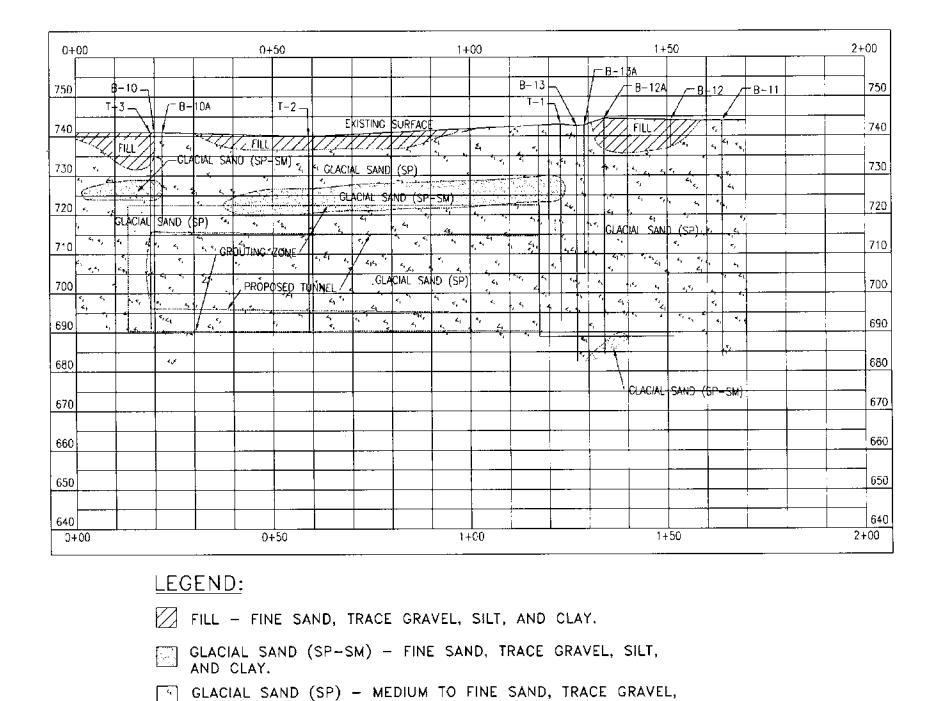
Figure 3. Geological profile

Three borings were drilled along the tunnel alignment to investigate soil subsurface conditions. In addition, several borings were drilled in the vicinity of the tunnel alignment. The borings revealed that the subsurface soils consist of a Fill layer, varying in thickness between 0 and 8 feet below ground surface, underlain by Glacial Sand extending to 77 feet below ground surface within the tunnel alignment. The Fill and the Glacial Sand layers consist predominantly of poorly graded sand (SP) and well graded sand (SW) based on visual classification. Standard Penetration Test (SPT) blow counts ranged from 6 to over 100 blows per foot (bpf). The high blow counts may be attributed to the presence of cobbles and boulders. The soil medium within the tunnel horizon was generally classified as medium-dense to dense sand. The Glacial Sands overlie the Glacial Till comprising silty clay to silty sandy clay including layers of sand. Figure 3, Geological Profile, presents geological conditions along the tunnel alignment.

The ground behavior for the Glacial Sand materials within the tunnel envelope, as classified in accordance with the Tunnelman's Ground Classification system (Heuer, 1974), was "slow to fast running."

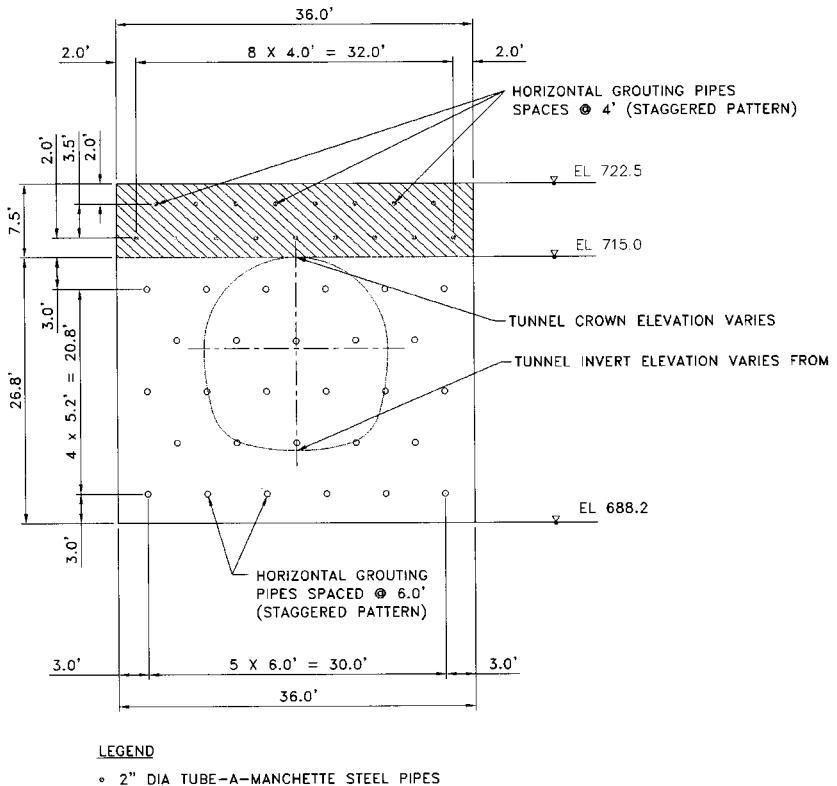
Permeation grouting creates an in-situ cemented soil matrix that increases strength and reduces permeability of the original soils and thereby increases tunnel stability during construction. This method is suitable for granular soils, sand, and gravel with less than 15% of fines that have sufficient void space to be permeated with fluid cement or chemical grout to produce the cemented matrix. Permeation grouting can be performed from vertical or horizontal pipe arrangements. Due to the limited access available on Michigan Street, horizontal grouting pipe arrangement was selected. The suggested design pipe arrangement is presented in Figure 4, Grouting Scheme (Design Phase).

2" DIA TUBE-A-MANCHETTE STEEL PIPES
1.5" DIA TUBE-A-MANCHETTE PVC PIPES

Permeation grouts are injected into the soil void spaces through tube-a-manchette (TAM) pipes. A stabilizer added to the grout controls gel time. The grout bonds with the soil particles, producing a composite soil mass with a higher shear and compressive strength than the un-grouted formation. Permeation grouting also reduces the soil permeability by filling the voids. This grouting technique does not use mechanical means to restructure the soil in the process, and therefore the soil structure remains relatively undisturbed. The operation creates minimal ground disturbances and reduces adverse deformation and damage to the ground formation.

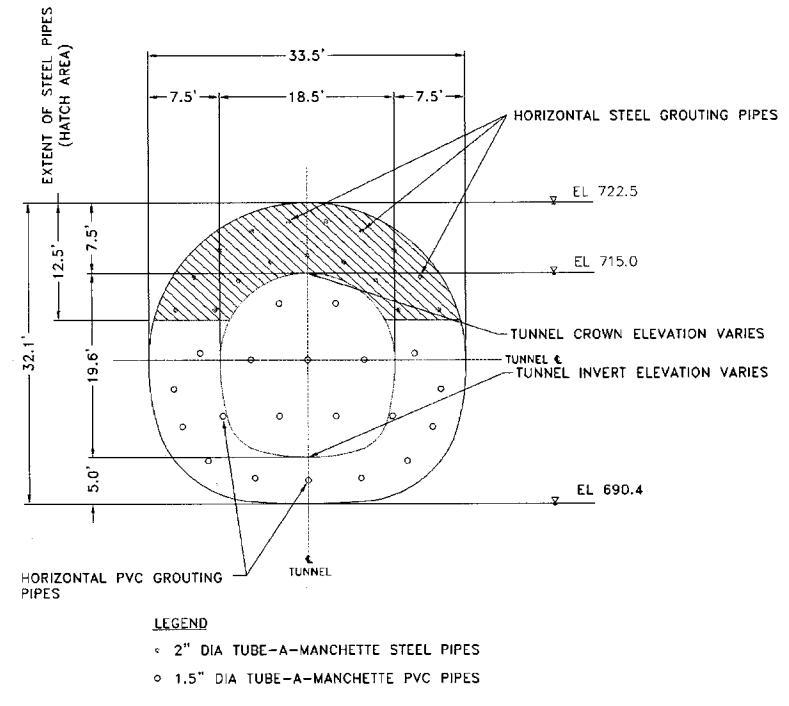
Figure 6. Grouting scheme (proposed and constructed by Kiewit)

A total of 21 steel TAM grout pipes, 2" diameter, were installed above the crown, and 20 PVC 1.5" TAM pipes were installed throughout the profile as seen on Figure 6. The total drilling length of 4,000' was completed in 18 working days on two 12-hour shifts per day. No obstructions such as cobbles or boulders were encountered during the drilling. However, it was a challenge drilling the pipes between soldier piles, tie back anchors and the MPBXs previously installed from the road surface above the tunnel.

Due to the compressed schedule, three tunneling contractors were invited to bid on the project as the contract documents were being developed. Only two contractors provided bids on the project. The lowest bid was 43% above the engineer's estimate. This was attributed to the constraints to the work area, the schedule as well as the unexpectedly increase in cost for raw materials and in particular the rising cost for permeation grouting. Value engineering proposals were requested from both bidders in an attempt to lower the price. Figure 6, Grouting Scheme shows a modified grouting pipe arrangement proposed by Kiewit that was accepted by the Owner's team. The modified grouting pipe arrangement reduced the lowest bid price by 15%.

unconfined compressive strength performance at seven and 28 days. The 28 day strength requirement was 150 psi. Grouting volume was based on a 30 percent void ratio of the Sands with a void filling factor of nearly 100 percent resulting in a target volume of 188,100 Gallons. Grouting started on February 6, 2006 and was completed in 29 workdays on March 13, 2006. The actual injected volume was 212,000 Gallons. The actual strength of the grouted soil ranged upwards of 500 psi to an estimated 1000 psi causing the tunnel excavation tool described below to almost reach its limit. The maximum distance between the pipes was five to six feet, which was at the limit for obtaining required soil mass permeation.
